Atkins -v- Scott (2008)

## Legal Case Study: Atkins -v- Scott (2008)

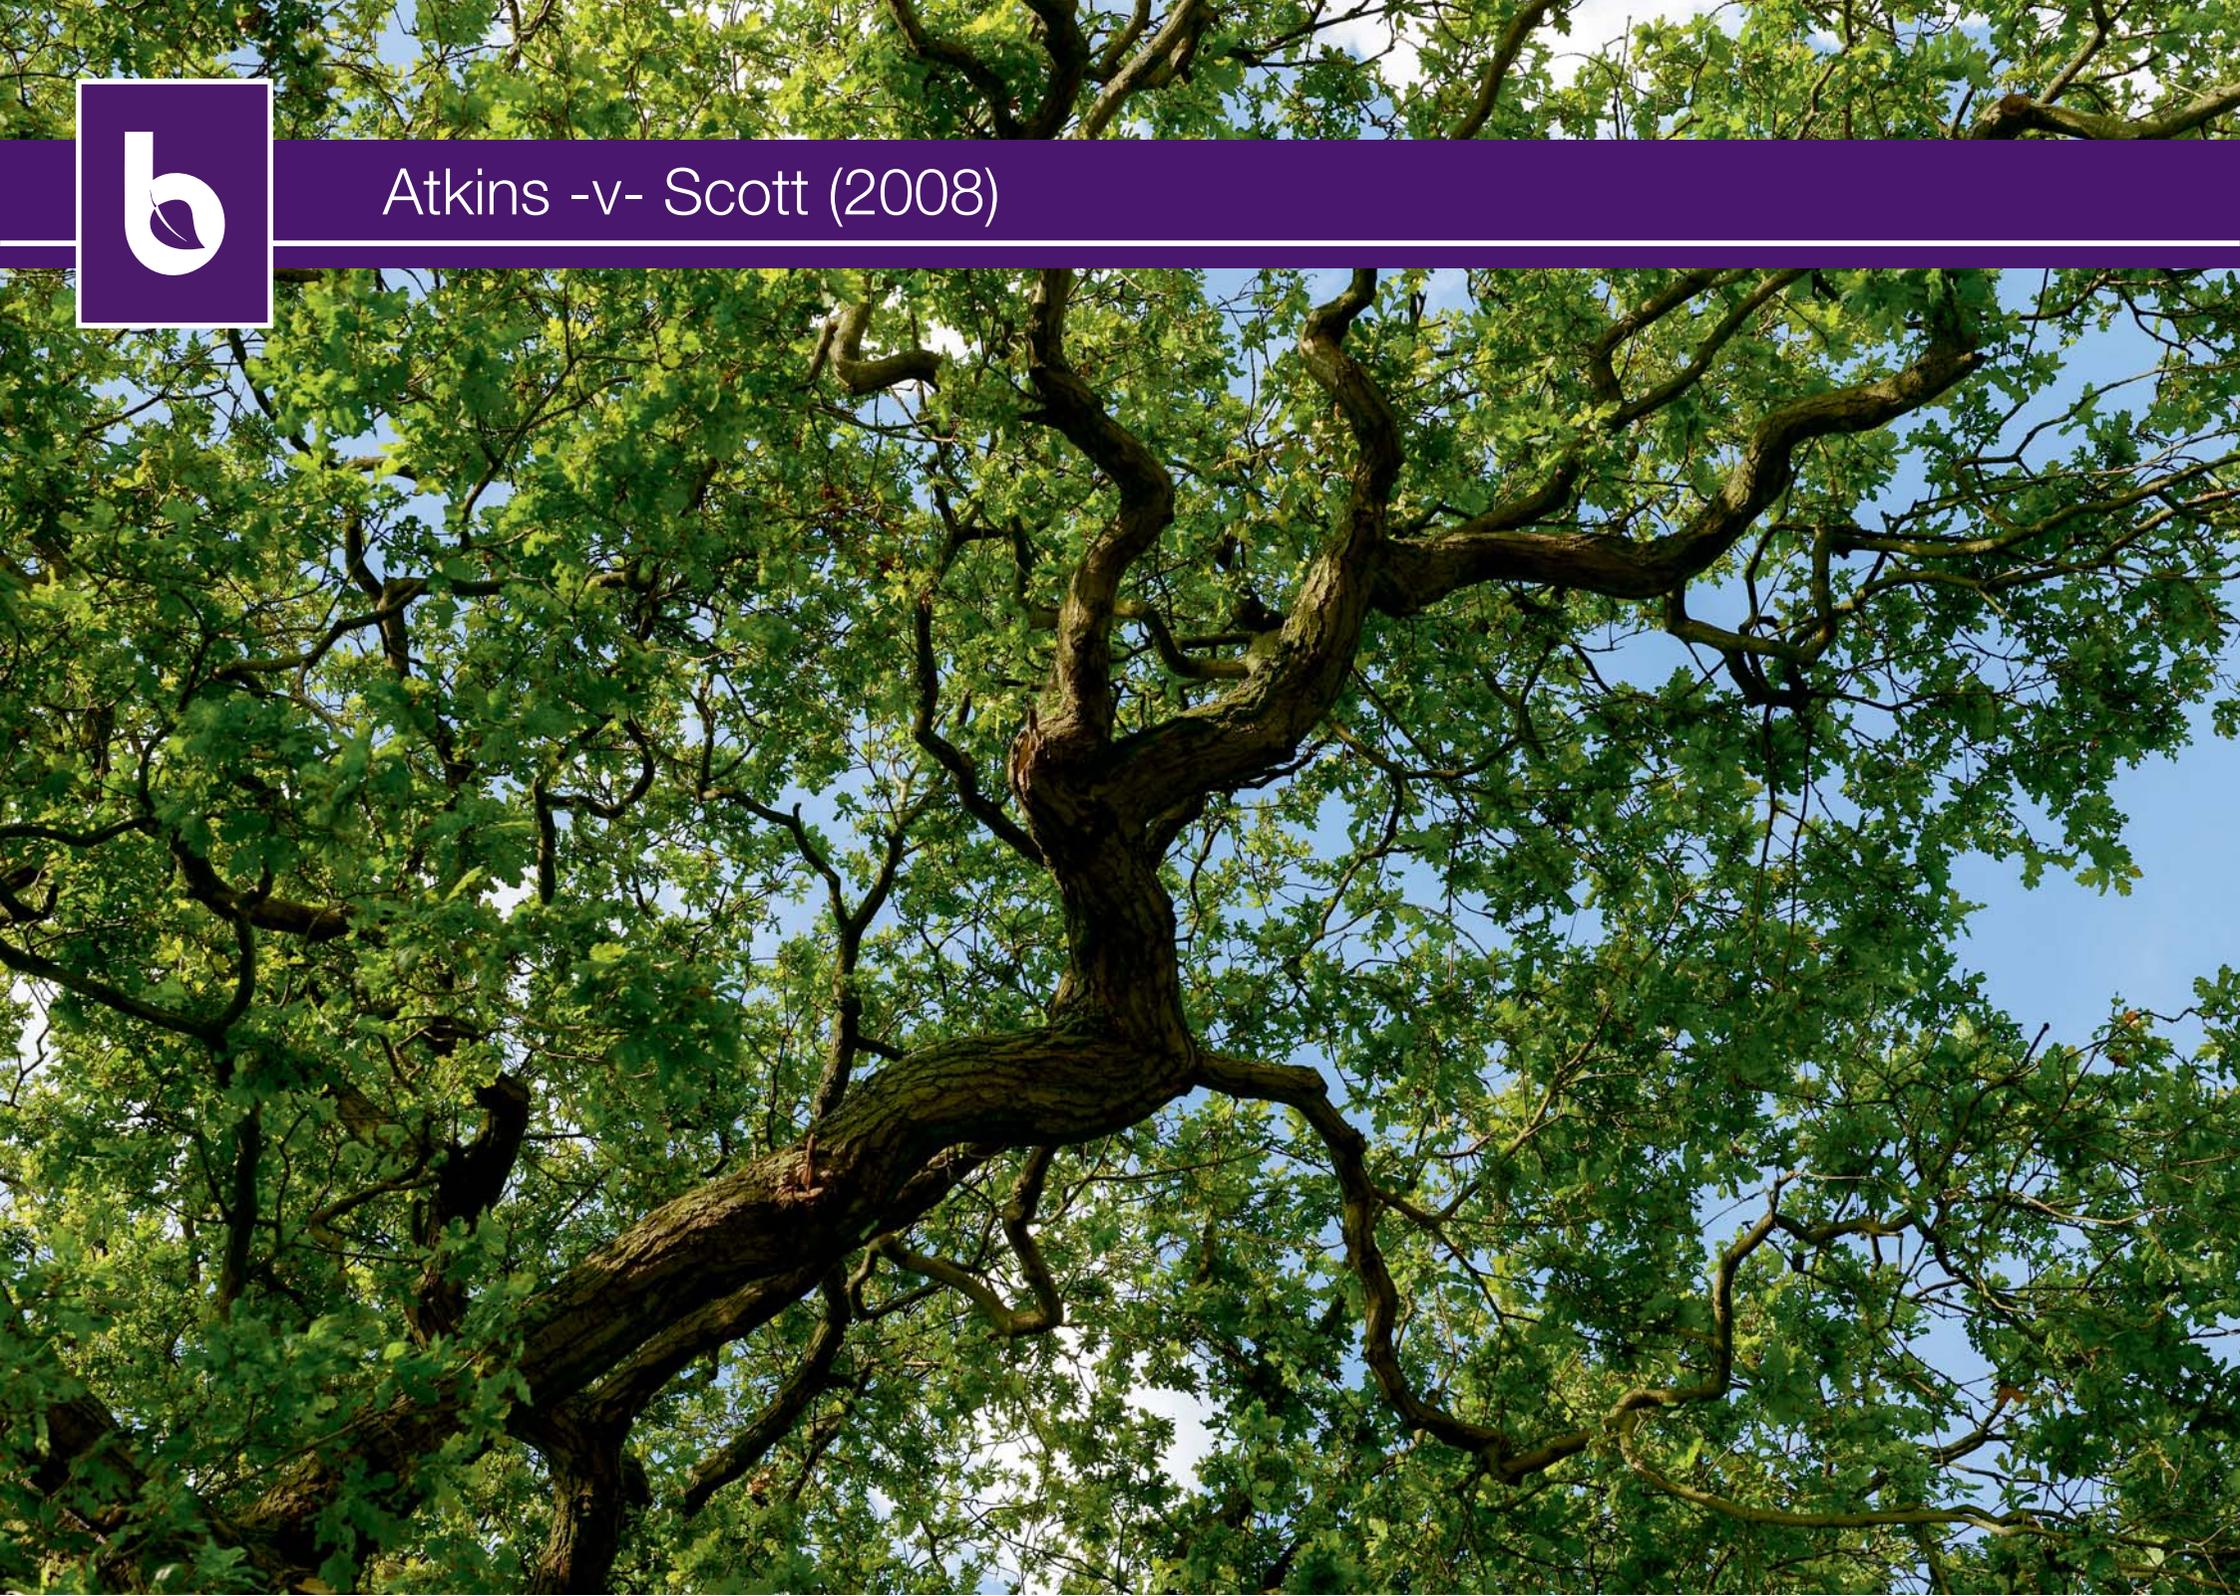
The branch that failed had internal decay and a crack in its upper side, but it was held that none of these defects would have been visible from a ground-based visual check. The case was heard in the Aldershot & Farnham County Court and the judgment issued on 14 August 2008 in favour of the Defendant (Case No: 6KB04804).

- 3. Expert disagreement on the orientation of the crack:** The branch that failed had a crack on one side about 80cm in length, which was discovered once the branch was on the ground after the failure. However, the experts disagreed on the orientation of the crack, i.e. at what angle it was facing when attached to the tree.

Unusually, this was resolved by lifting the fallen part of the branch and attaching it back to the tree with temporary ties to recreate a realistic representation of how it would have been oriented before the failure.

This reconstruction confirmed that the crack was facing upwards, and not downwards, which was an important consideration in the final conclusion that the crack would not have been discoverable from the ground-based quick visual check level of inspection.
