Atkins -v- Scott (2008)

## Legal Case Study: Atkins -v- Scott (2008)

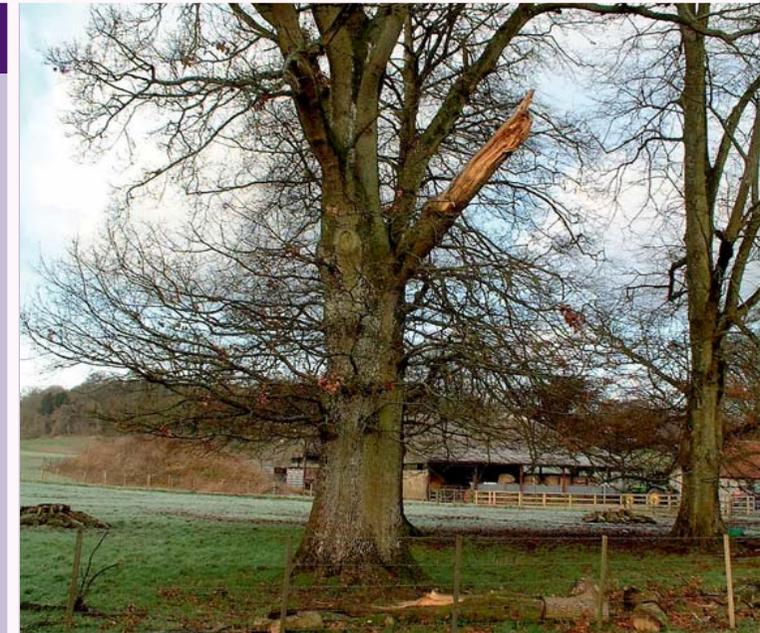
- 3. Expert disagreement on the orientation of the crack:** The branch that failed had a crack on one side about 80cm in length, which was discovered once the branch was on the ground after the failure. However, the experts disagreed on the orientation of the crack, i.e. at what angle it was facing when attached to the tree.

Unusually, this was resolved by lifting the fallen part of the branch and attaching it back to the tree with temporary ties to recreate a realistic representation of how it would have been oriented before the failure.

This reconstruction confirmed that the crack was facing upwards, and not downwards, which was an important consideration in the final conclusion that the crack would not have been discoverable from the ground-based quick visual check level of inspection.
